NACA RM E57C12

ORIGIN AND DEVELOPMENT OF LEADING-EDGE CRACKS IN

TURBOJET ENGINE BUCKETS

By D. F. Springsteen, C. A. Gyorgak,  
and J. R. Johnston

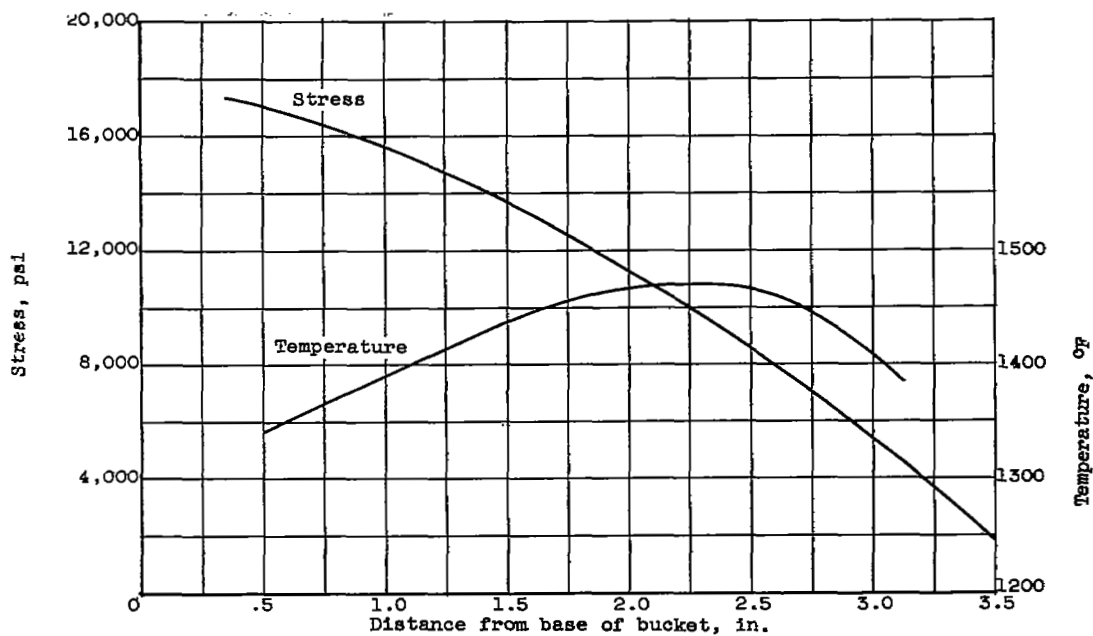
The temperature and centrifugal-stress distribution along the span of a J47-25 bucket operating at full power is shown in figure 2. In the initial stage of the test, the steady-state temperature distribution was obtained by operating, in the engine, buckets equipped with thermocouples located at 1/2-inch intervals along the span of the bucket. More information about the equipment and procedure for making a temperature survey is given in reference 2. The centrifugal-stress distribution was calculated as explained in reference 3.

Figure 2. - Temperature and stress distribution. J47-25 turbine buckets operated at rated speed, 7950 rpm; tailpipe gas temperature, 1275° F; (S-816 density, 0.310 lb/cu in.).

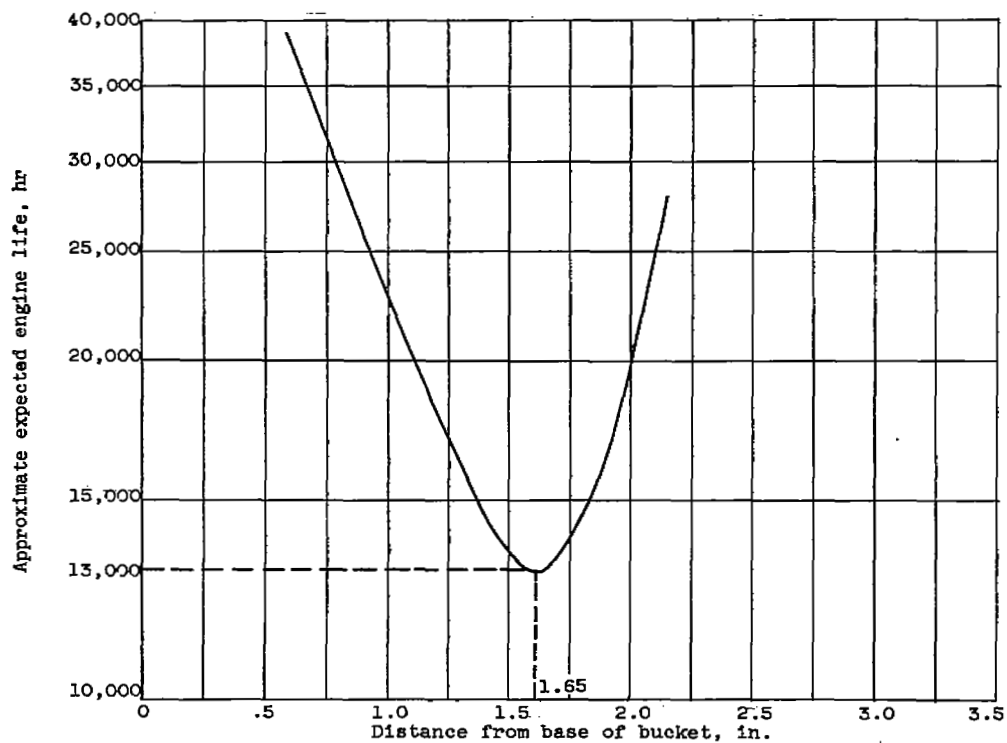
For example, for an S-816, J47-25 bucket, this critical cross section is 1.6 inches from the base, and the theoretical life of the material at this section is about 13,000 hours (fig. 3). These calculations were based on bar-stock stress-rupture data for 1300°, 1400°, and 1500° F. Simple interpolations were used to determine the intermediate isothermal-stress values, and straight-line extrapolations were used to approximate the expected life above 1000 hours. While straight-line extrapolations introduce inaccuracies, they do offer a means of obtaining order-of-magnitude values.

The stress-rupture values for the other five materials are generally higher than for S-816; therefore, the minimum theoretical life for these alloys would be expected to be greater than the 13,000-hour value for S-816 shown in figure 3. A detailed explanation of the procedure used for determining the location in the bucket of the critical cross section is given in reference 4.

Figure 3. - Critical zone in an S-816, J-47-25 turbine bucket. Calculations based on General Electric data for 1300°, 1400°, and 1500° F. Simple interpolations were used for intermediate temperature.

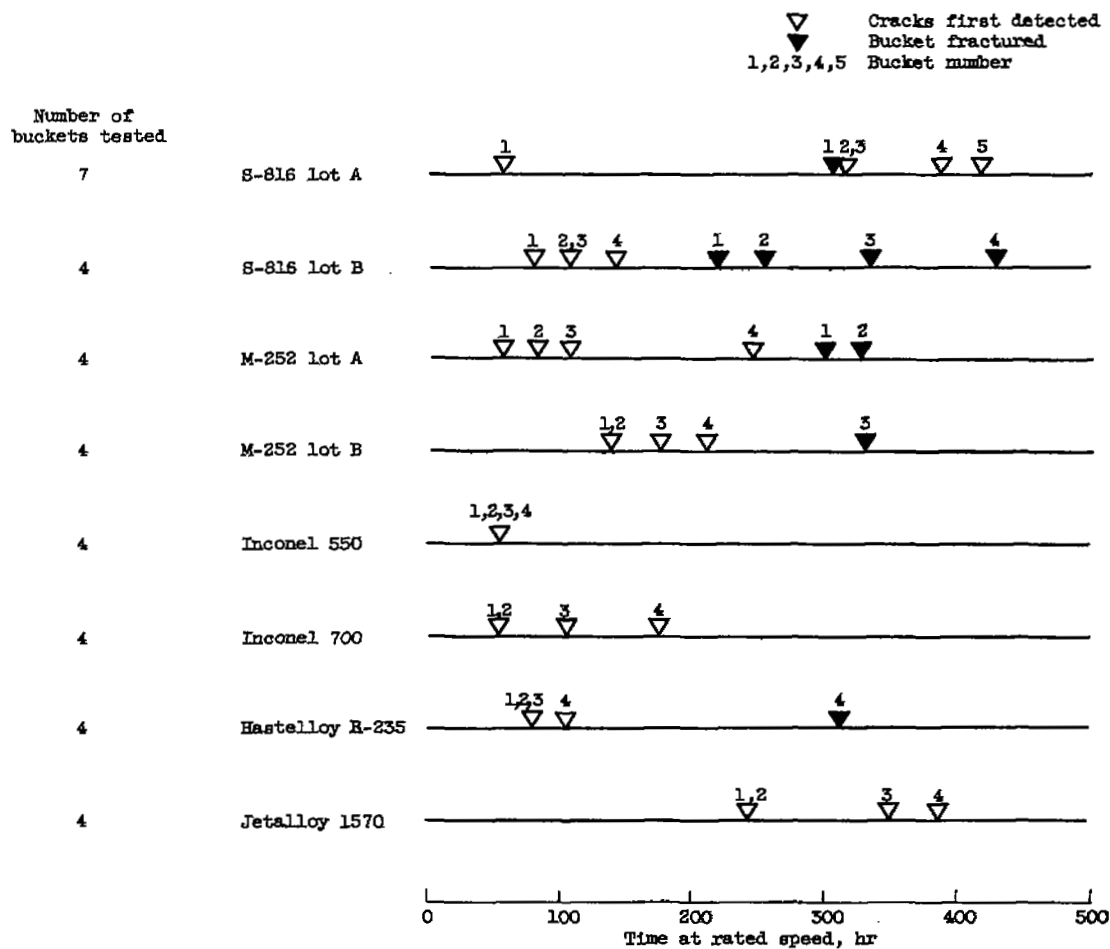
Performance of as-received buckets. - All the lots of as-received materials developed cracks before 245 hours of operation at rated speed as shown in figure 5. In three of these materials, M-252 lot A, Inconel 550, and Inconel 700, cracks were detected as early as 55 hours. The two materials that displayed the best resistance to cracking were Jetalloy 1570 and S-816 lot A. Cracks were first noted in Jetalloy 1570 at 245 hours. Although one of the S-816 lot A buckets showed cracks at 55 hours, this short time to cracking was so far outside the scatter band for the material that it could not be considered a representative bucket. For the remainder of the buckets of the S-816 lot A group no cracks were observed until 312 hours of engine operation.

Figure 5. - Comparison of performance of as-received bucket materials. Test discontinued at 500 hours.

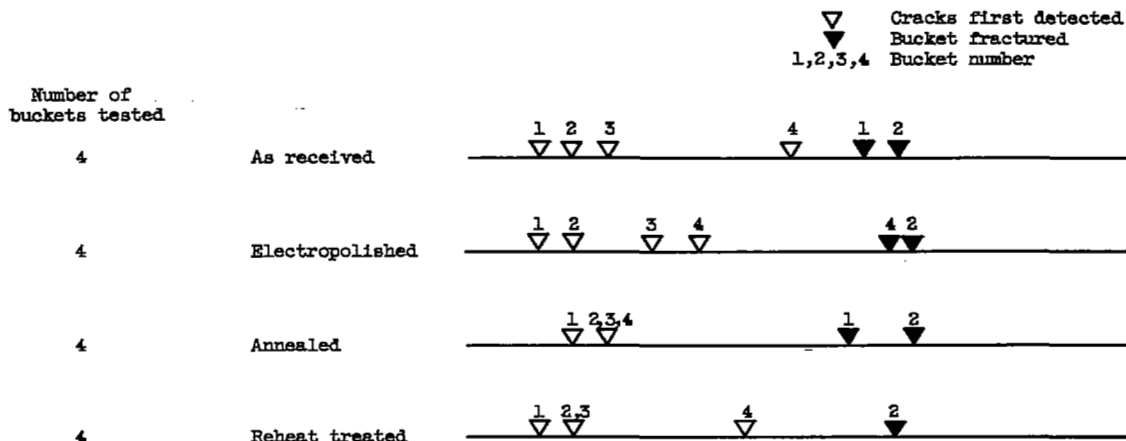
(a) M-252 lot A as-received and specially treated buckets.

Performance of specially treated M-252 buckets. - The crack resistance and service-life performances for all the groups of both M-252 lot A and M-252 lot B were very similar (figs. 6(a) and (b)). When compared on the basis of average time to cracking, all the groups (as-received, electropolished, annealed, and reheat-treated) for both materials cracked at about the same time, approximately 125 hours.

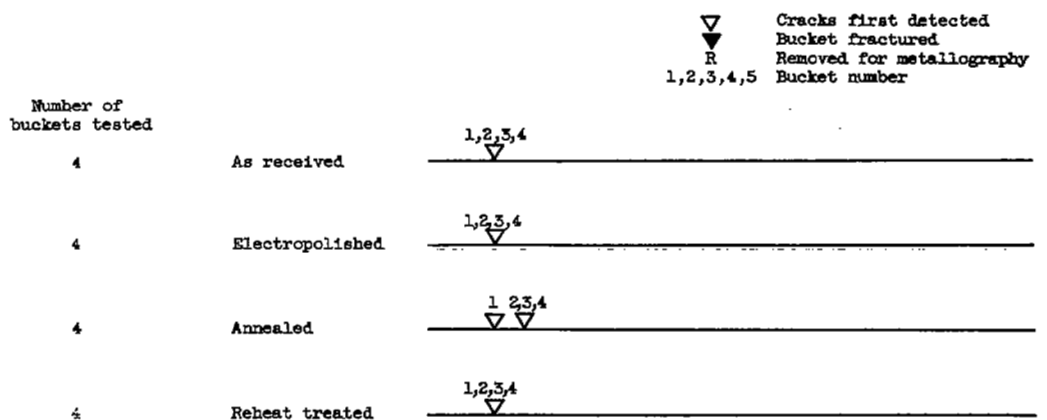
(d) Inconel 550 as-received and specially treated buckets.

Performance of specially treated Inconel 550 buckets. - All the groups of the specially treated and as-received Inconel 550 buckets had cracks at 55 hours as shown in figure 6(d). None of the groups had fractured buckets when the test was discontinued after 500 hours of operation.
